4321 Main St. Denver, CO

Inspection Date:

5/6/2010

Report Number:

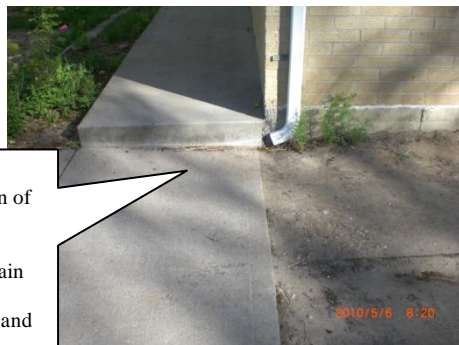
Driveway is pitched towards home. Recommend installation of a downspout extension. Water needs to drain away from the home. If the water does not drain away it could lead to water infiltration into into basement and or foundation damage.

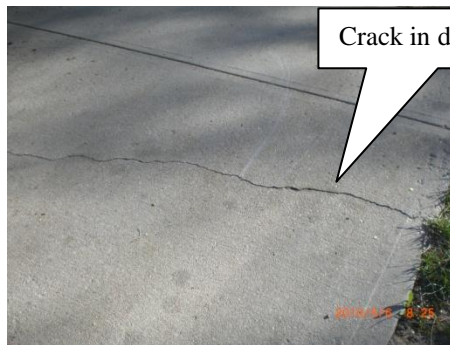
Crack in driveway.

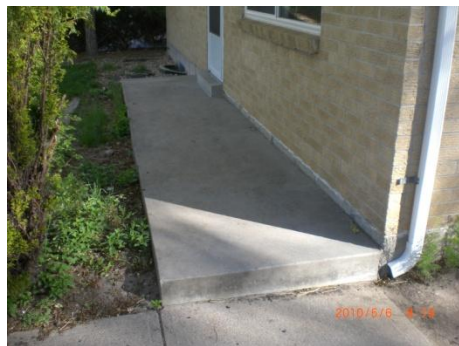
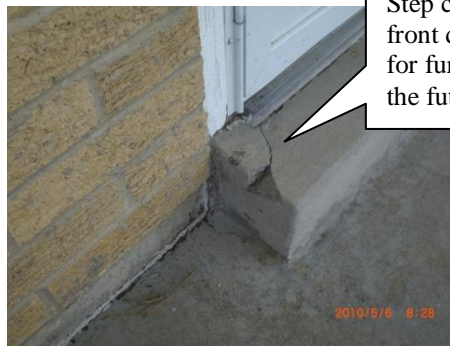
Step cracked at left of front door. Monitor for further damage in the future.

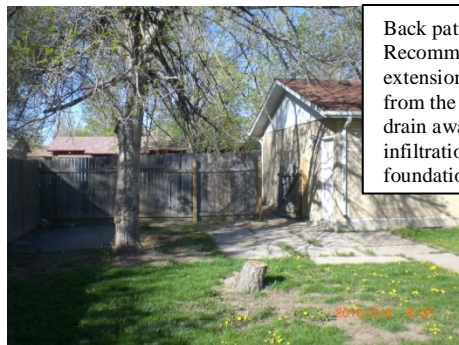
Back patio is pitched towards home. Recommend installation of a downspout extension. Water needs to drain away from the home. If the water does not drain away it could lead to water infiltration into basement and or foundation damage.

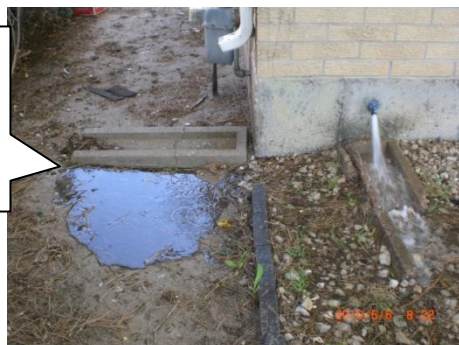
N. W. corner of home. Negative grade. Water is not draining away from the house. Recommend additional backfill and downspout extensions.

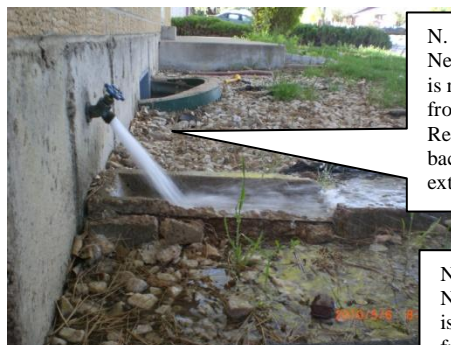
N. W. corner of home. Negative grade. Water is not draining away from the house. Recommend additional backfill and downspout extensions

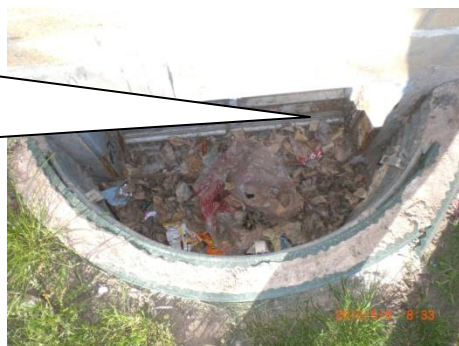
Negative grade causes window wells to accumulate water. The window frame is starting to rust at the bottom. Also recommend a window well cover to help keep debris out of window well.

Recommend window well covers.

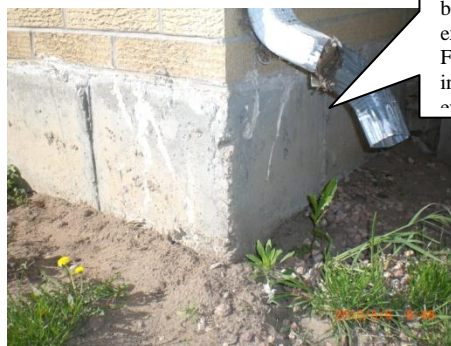
N. E. corner of home. Negative grade. Water is not draining away from the house. Recommend additional backfill and downspout extensions. Foundation has cracks in corner. Recommend evaluation by a

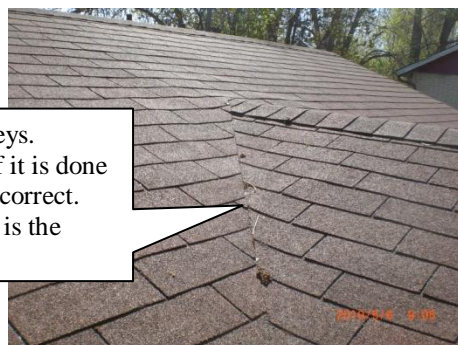
Asphalt shingle valleys.
 Unable to evaluate if it is done correctly. It appears correct.
 Diagram to the right is the correct method.

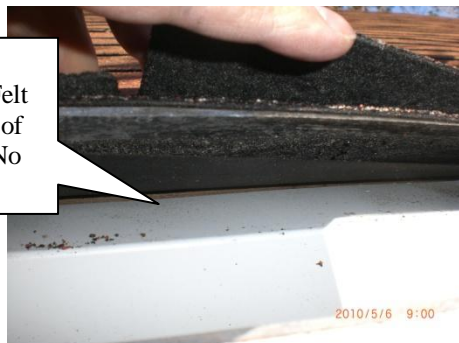
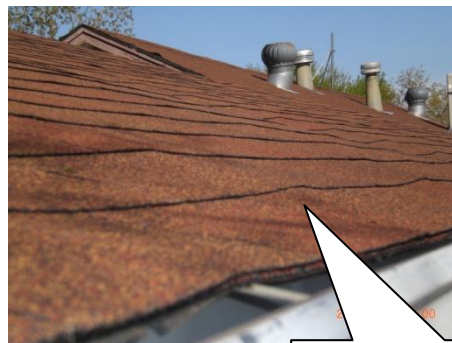
Roof is wavy and the roof has a spongy feel to it when walked on. When observed from the attic the cause is from the use of 3/8" plywood sheathing. This could be a safety hazard for people walking on the roof. The sheathing may not last as long as the average. See attic pictures.

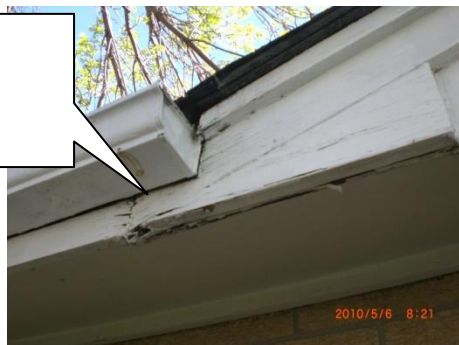
Recommend having a qualified painter paint/patch and caulk exterior trim.

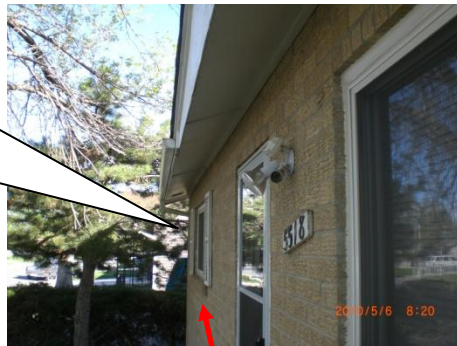
Most windows are vynal double paned. Front bedroom has a hole through both panes of glass. Recommend repair by a qualified window contractor.

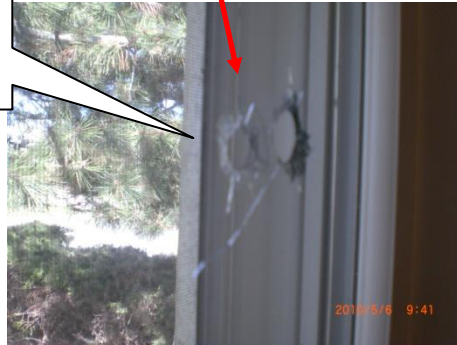
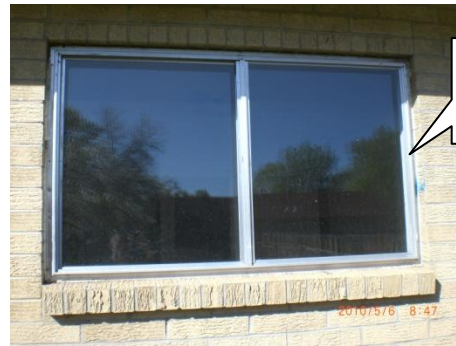
Front bedroom has a hole through both panes of glass. Recommend repair by a qualified window contractor.

Back (2) windows: Metal with Storms. Missing screens.

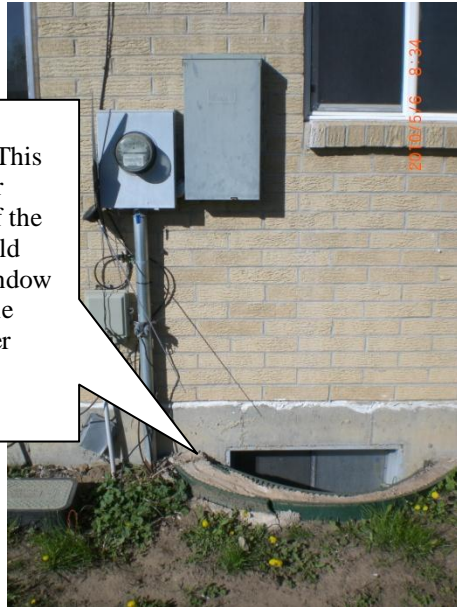
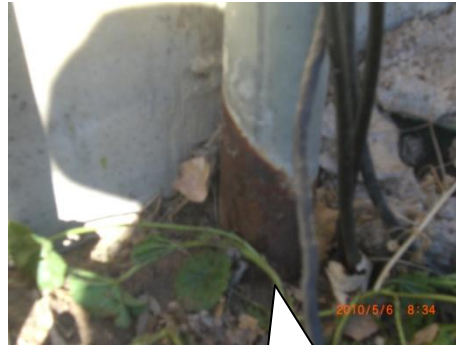
Electrical panel installed above the window well. This does not allow the proper working space in front of the panel. An electrician could accidentally step in the window well while working on the pane. Recommend further evaluation by a licensed electrician.

Electric service riser pipe is metal and starting to rust. Recommend evaluation by a licensed electrician.

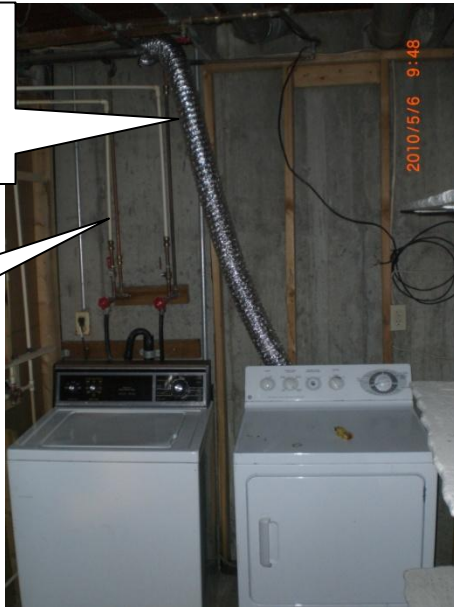
Recommend replacing the upper portion of the dryer vent with solid piping. The flex piping should only be used on the final few feet connecting to the dryer.

Plumbing pipes not secured. Recommend repair by a licensed

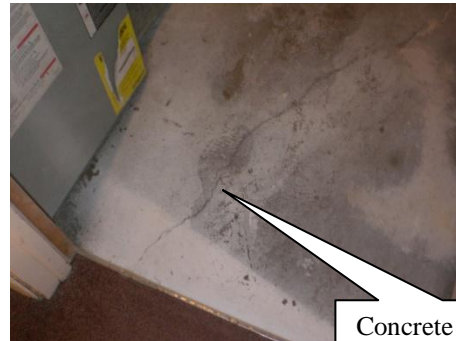
Concrete floor is cracked. It doesn't appear to be an active crack. Monitor.

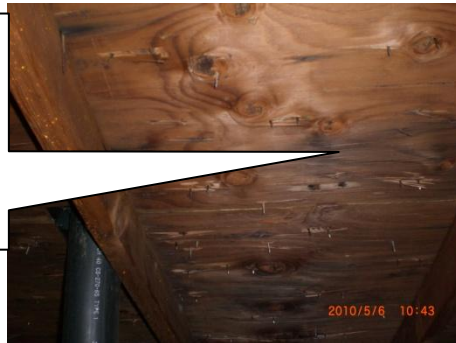
Evidence of water leak. Unknown if this is an active leak or if corrected the last time the roof was replaced. If desired have a qualified roofer evaluate further.

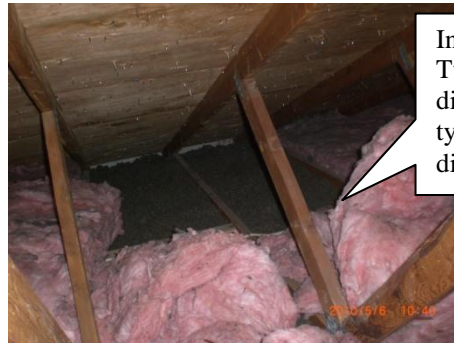
Insulation: Two different types. Also displaced.

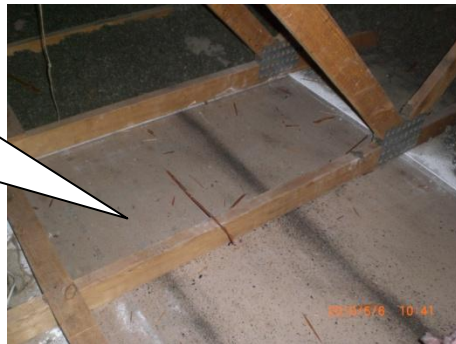
Insulation missing above living room. Recommend having entire attic insulation evaluated/repared by a qualified insulator.

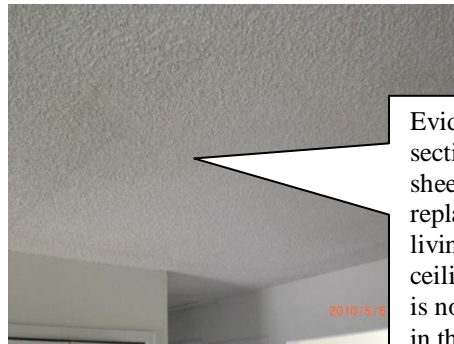
Evidence of a section of sheetrock replaced in living room ceiling. There is no insulation in this area.

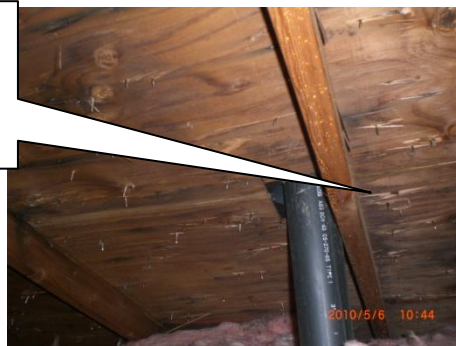
Evidence of water leak. Unknown if this is an active leak or if corrected the last time the roof was replaced. If desired have a qualified roofer

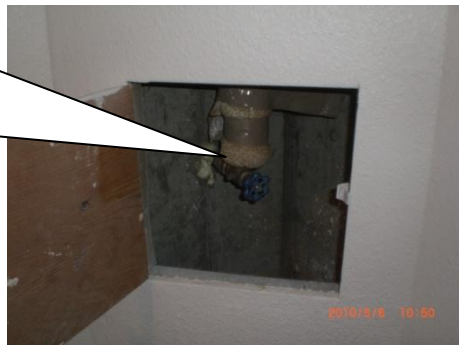
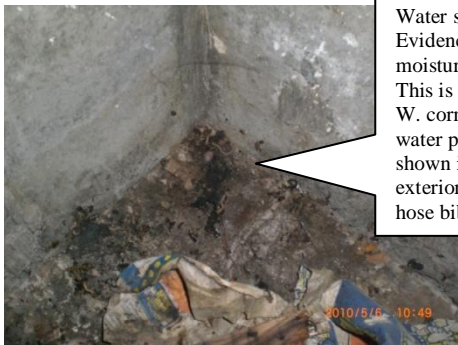
Main water shut off in lower level N. W. bedroom. There is a towel wrapped around the pipe around the pipe. Recommend having a licensed plumber evaluate if there is a leak.

Water shut off area. Evidence of moisture intrusion. This is below the N. W. corner where the water pools as shown in the exterior pictures at hose bib.

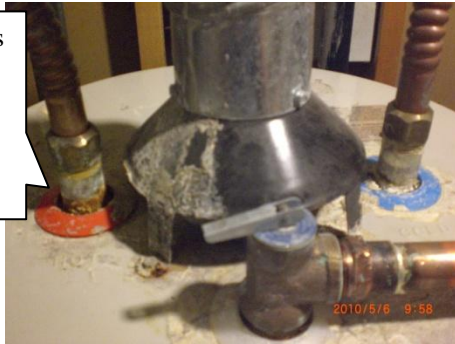
Water heater connections have some corrosion. Recommend repair by a licensed plumber.

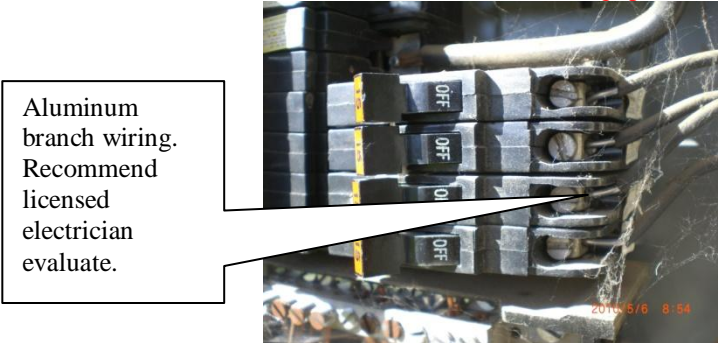
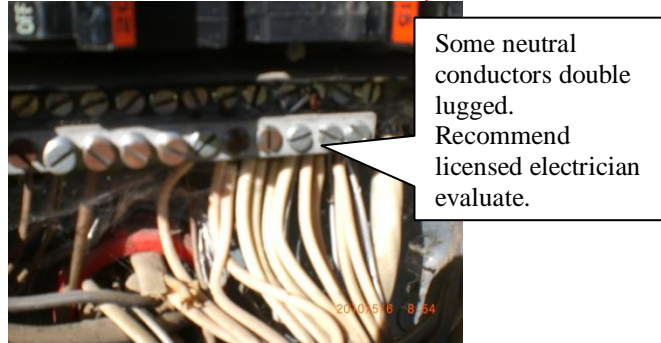
MAIN PANEL:
 Panel size appeared to be compatible to service size.
 Panel was full and may need to be upgraded for future needs.
 Panel cover was missing some screws.

Aluminum wires have been used for branch wiring (part) - recommend licensed electrician evaluate the system.
