4321 Main St. Denver, CO

Inspection Date:

5/6/2010

Report Number:

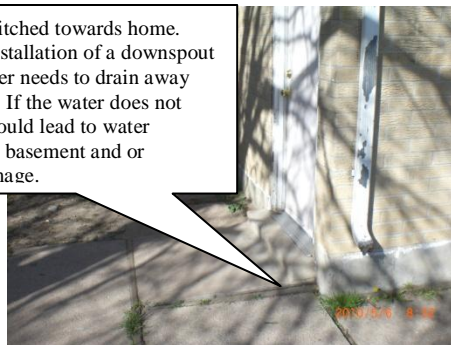
Back patio is pitched towards home. Recommend installation of a downspout extension. Water needs to drain away from the home. If the water does not drain away it could lead to water infiltration into basement and or foundation damage.

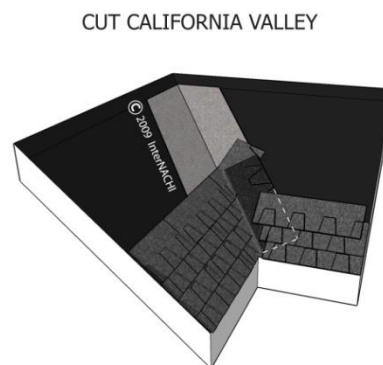
Asphalt shingle valleys.
 Unable to evaluate if it is done correctly. It appears correct.
 Diagram to the right is the correct method.

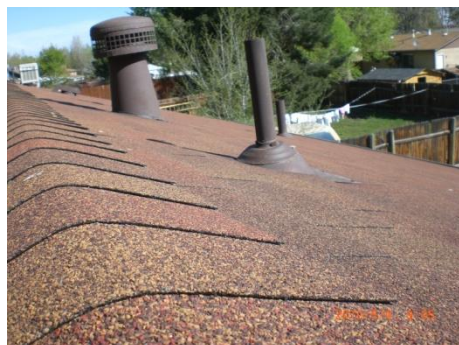
Roof is wavy and the roof has a spongy feel to it when walked on. When observed from the attic the cause is from the use of 3/8" plywood sheathing. This could be a safety hazard for people walking on the roof. The sheathing may not last as long as the average. See attic pictures.

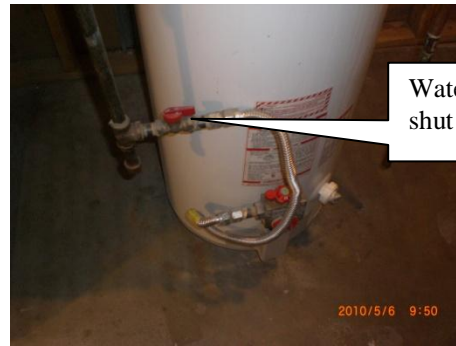
Water heater gas shut off valve.
